All Pro Home Inspection Services

Property Inspection Report

123 Fake Street, Somewhere, AL 35763
Inspection prepared for: SAMPLE REPORT
Real Estate Agent: -

Date of Inspection: 7/22/2019 Time: 9:00 AM
Age of Home: 2003 Size: 3776
Weather: Partly Cloudy Showers/86 F
Order ID: 210

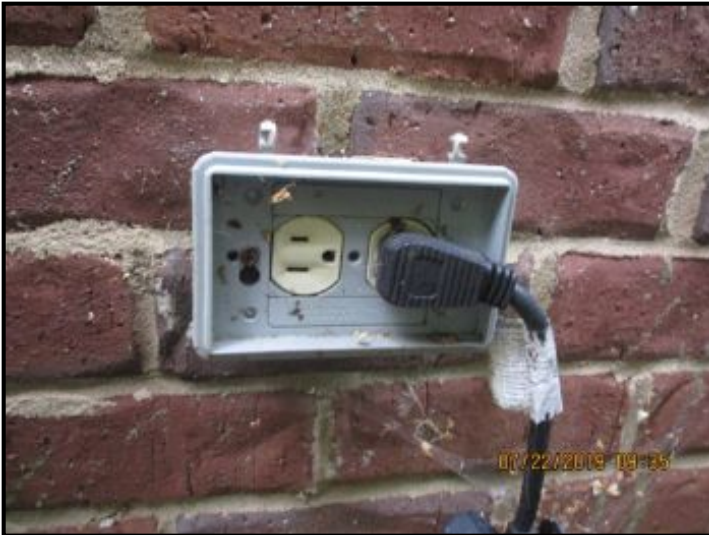
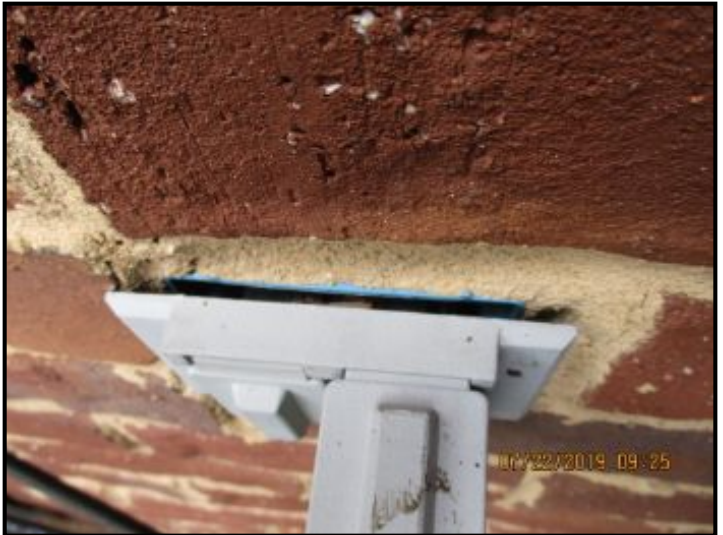
The cover plate for the exterior receptacle near the condensing units is loose and does not seal the electrical box. Have this repaired by a licensed electrician.

Loose exterior receptacle cover.

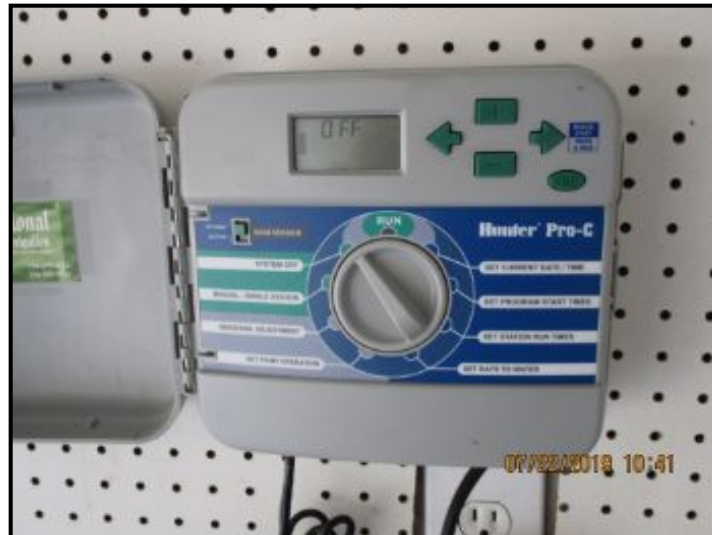
The sprinkler system is not functional.

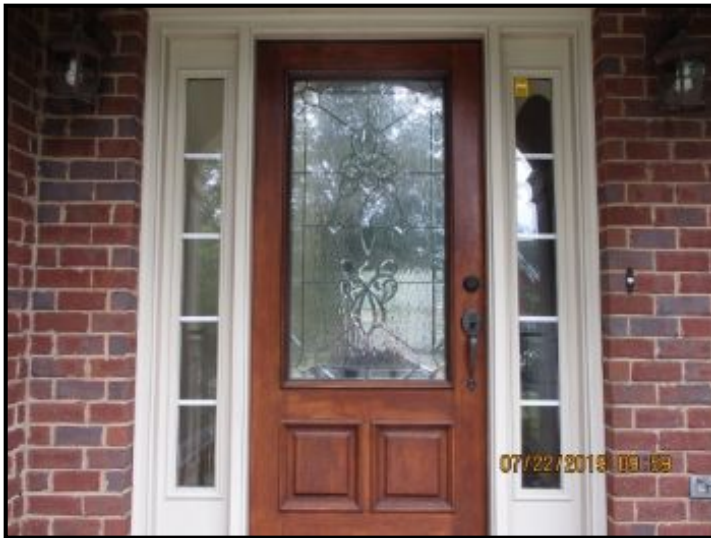
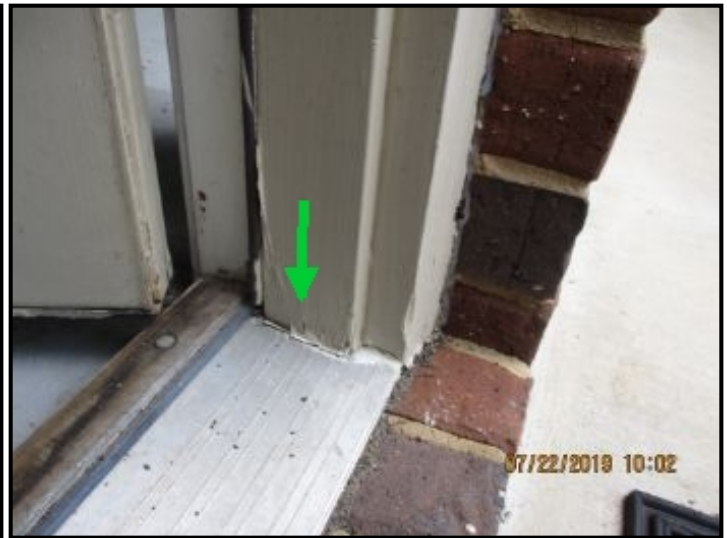
The patio door is leaking at the threshold. The sub floor below the door has some rot and water staining. This has occurred because the door was not properly flashed when it was installed. The left side of the door jamb has been repaired at the threshold as it was likely rotted. It is important to keep the threshold sealed at the jamb and to the brick with Silicone to prevent further damage to the structure. Ideally, the door needs to be pulled out and properly flashed however, proper maintenance should prevent further damage.

Patio door leaks at the threshold.

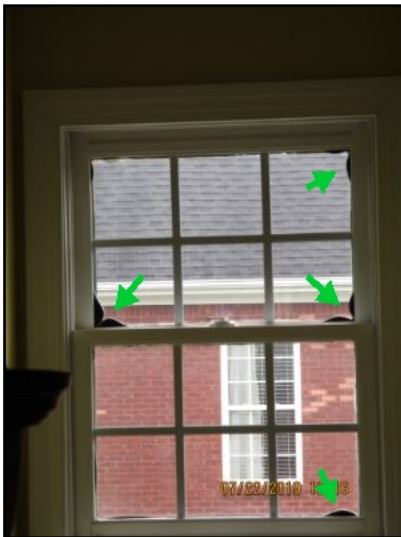
The thermal seals are beginning to fail on some of the windows due to age. There are several windows that have moisture between the glass and a window in the second floor front left bedroom is damaged from moisture. I recommend that you have the failed window sashes replaced.

Thermal seal deterioration

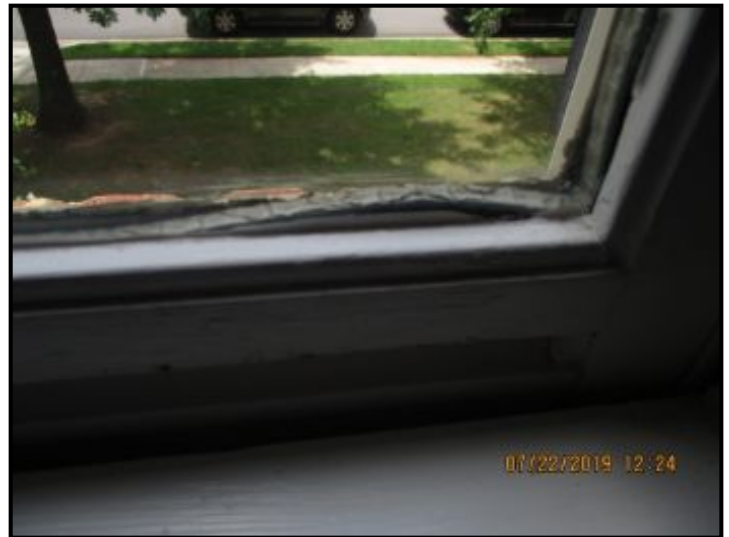
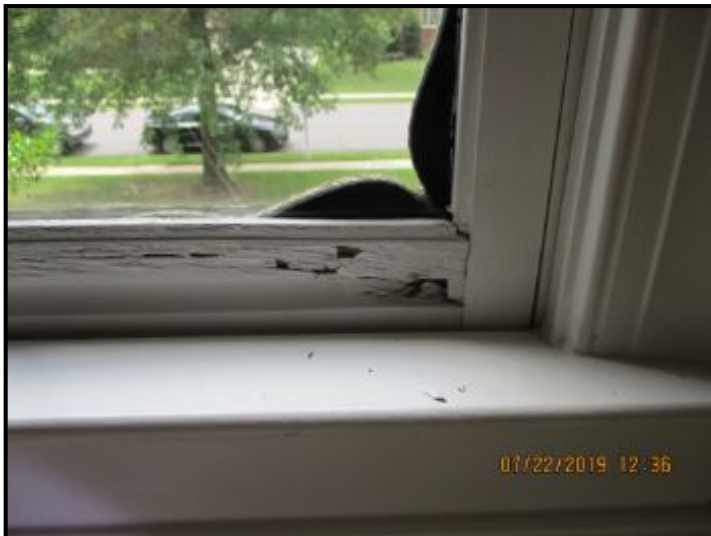
This window is damaged and needs to be replaced.

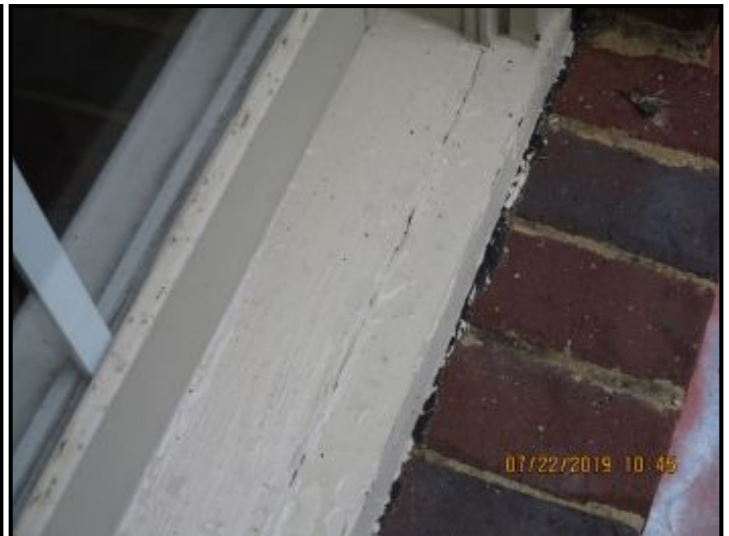
Maintain the wood window frames.

The wood window frames need to be well maintained to prolong the life of the windows. I found soft spots on a few windows and some cracking paint. The windows will need to be scraped, spot primed and painted in the near future. These windows frames will last a long time with proper maintenance.

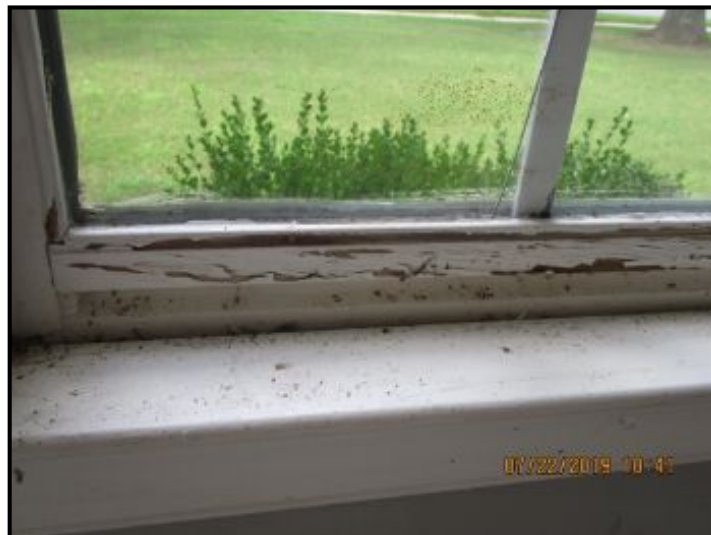
There are cracked windows in the garage and master bedroom. Have these windows replaced.

Garage window is broken and moisture damaged.

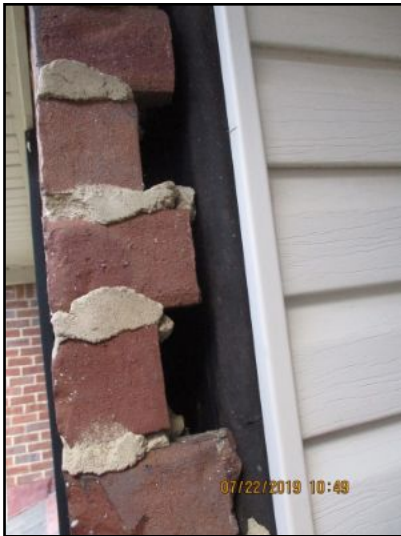
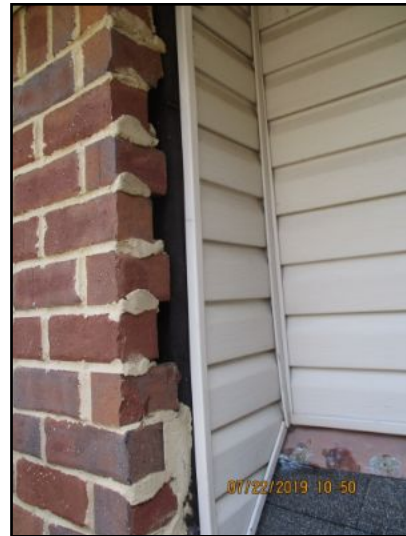
A piece of aluminum siding is missing at the right side of the gable over the front porch leaving a few large voids. These areas will allow water entry and easy access for birds, insects and rodents. There is evidence of rodent entry in the adjacent attic area. Have this area properly repaired by a licensed siding contractor.

Missing siding.

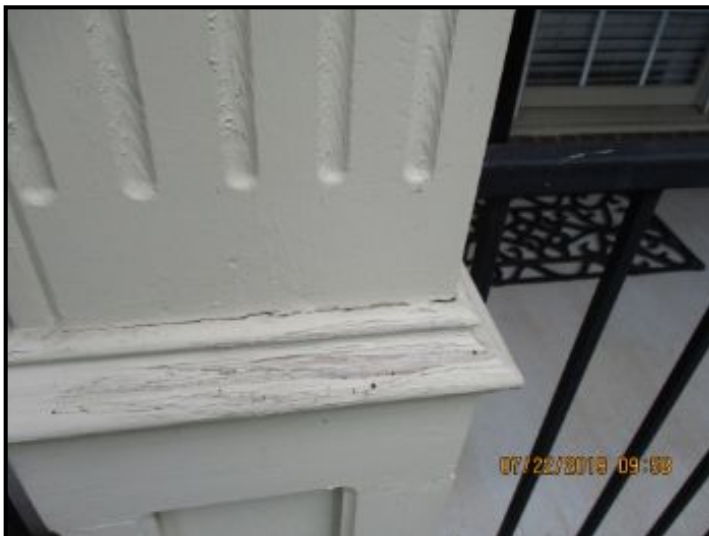
The porch columns are in need of repair and painting. A piece of trim is missing on a column base and the paint is peeling and cracking in a few areas. Have this repaired.

Cracking paint on columns.

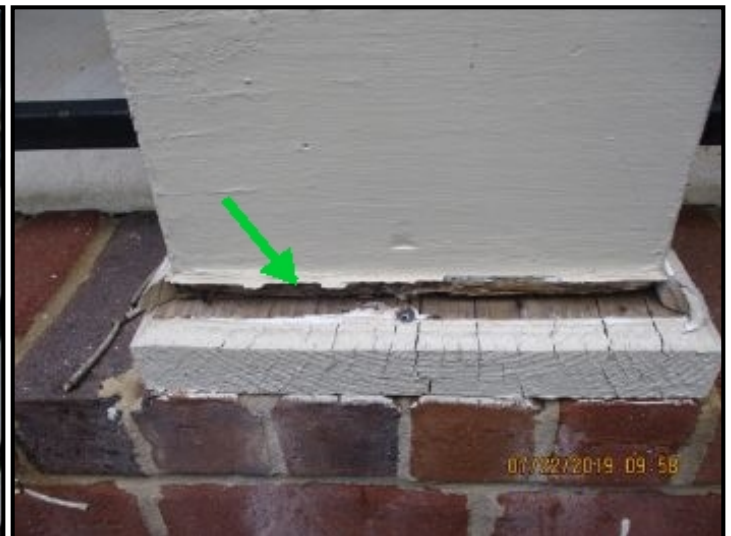
Missing trim on column.

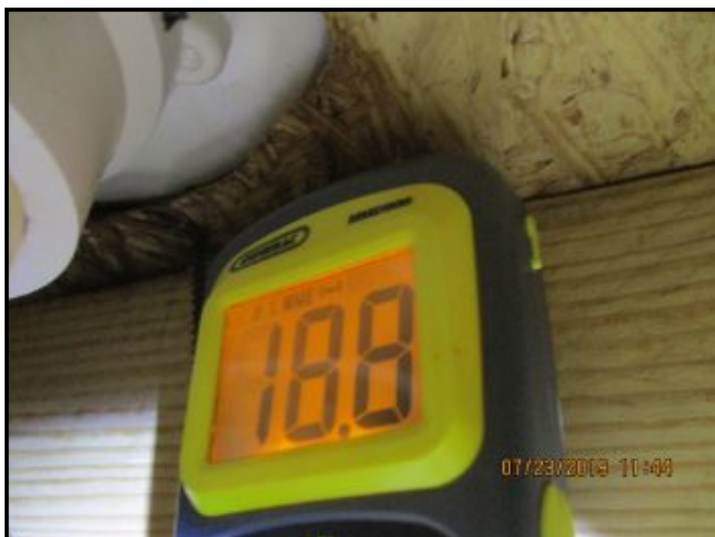
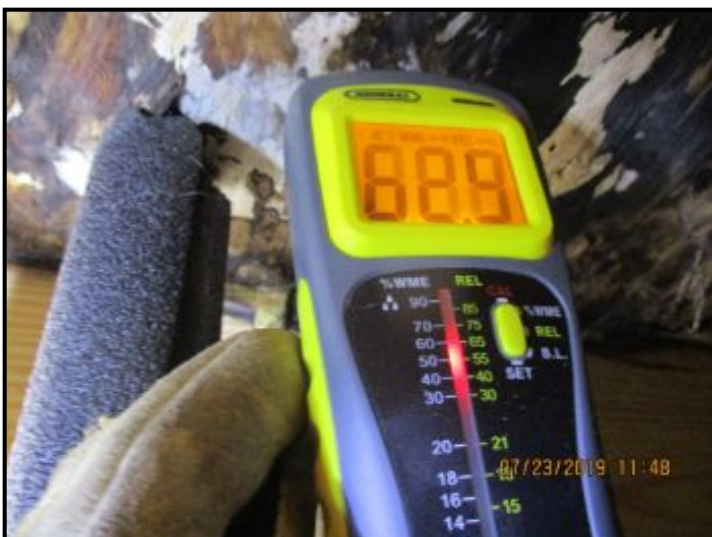
MAJOR REPAIR: There is an active leak with water damage to the sub floor under the laundry sink or water heater area. A water heater or supply line may be leaking. The sub floor is rotted in this area. The area tested as wet with a moisture meter. Have this evaluated and repaired by a licensed contractor.

The master shower drain is leaking. The sub floor has an elevated moisture content on the water stain. The sub floor is not rotted. Have this evaluated and repaired by a licensed contractor.

Area under shower drain - 19% moisture content. Area under water heaters - 63% moisture content.

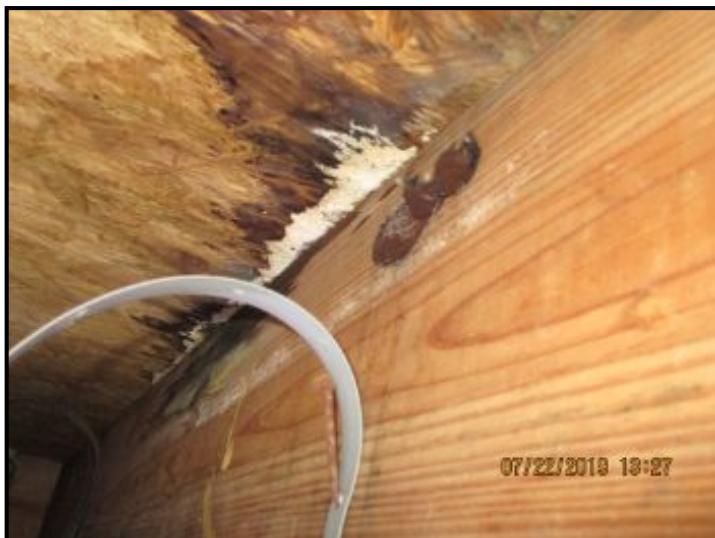
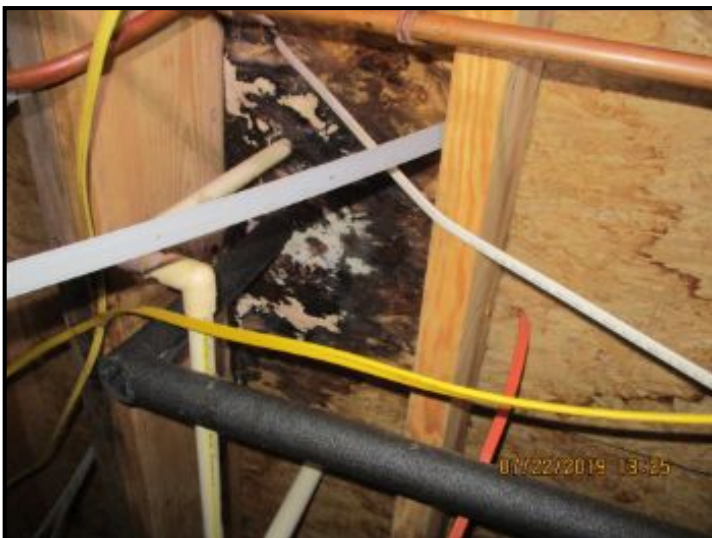
Area under water heater.

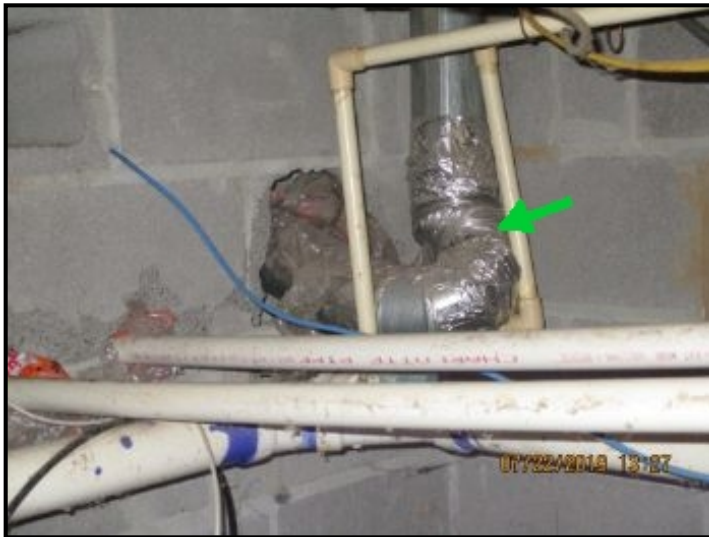
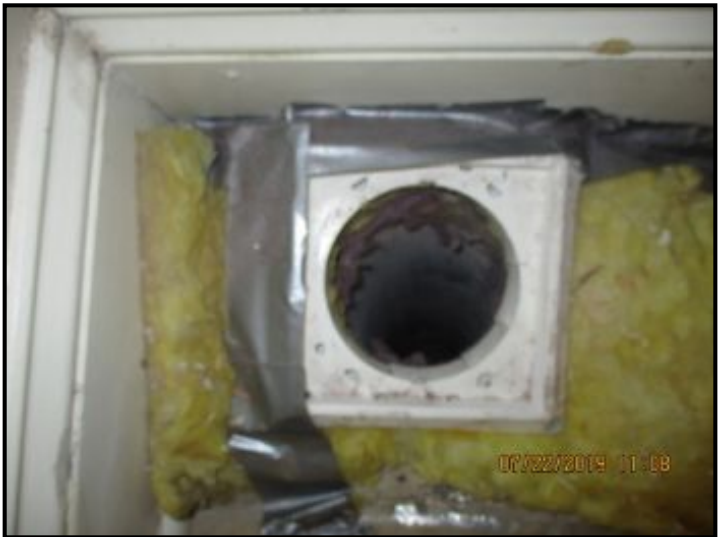
SAFETY: Flex duct has been used for the dryer vent in the crawlspace and the connection to the floor is broken. This duct is required to be constructed of smooth wall duct to the exterior. Have this repaired.

Flexible dryer vent pipe.

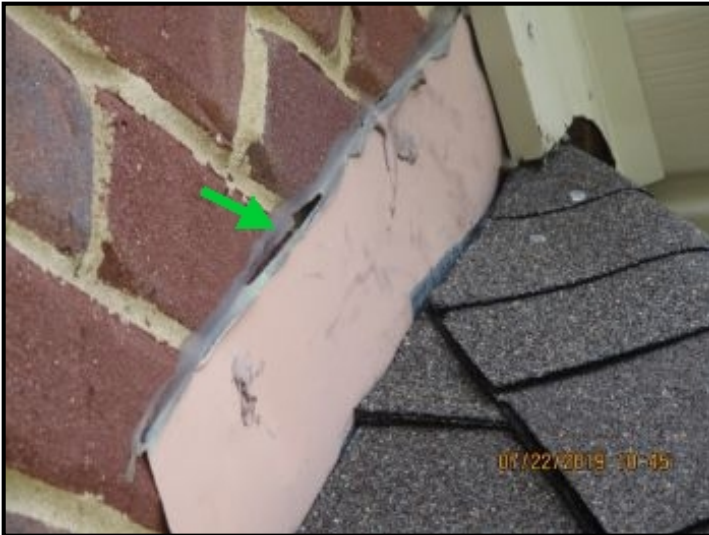
The Silicone sealant at the brick on the roof flashing over the right front porch gable needs repair. Have this repaired by a licensed roofing contractor.

This flashing needs to be caulked.

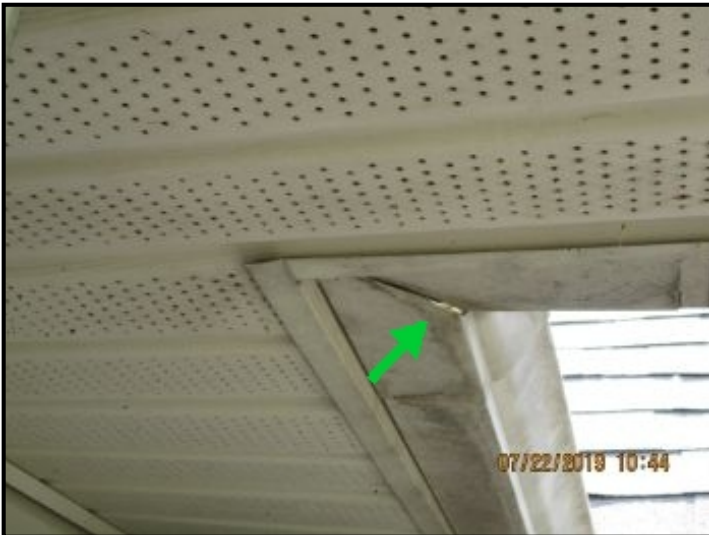
Some of the gutter corners and seams are leaking. I would have the gutter system evaluated and repaired as necessary.

Leaking gutter seams and corners.

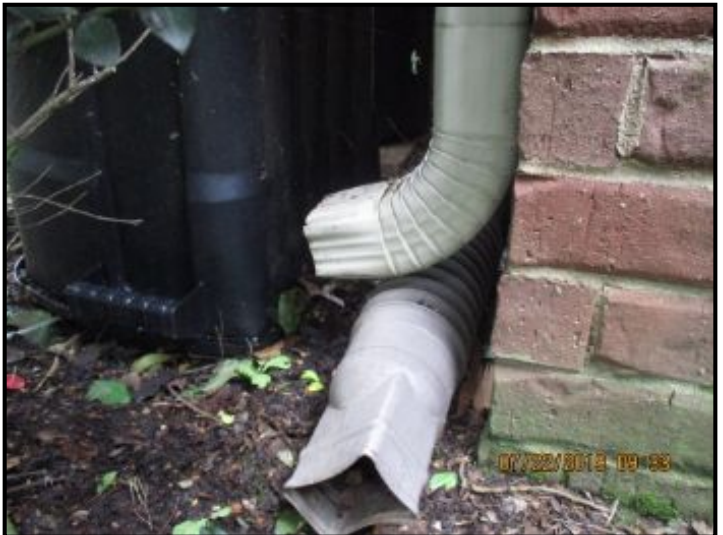
Down spouts need extensions to carry water away from the foundation.

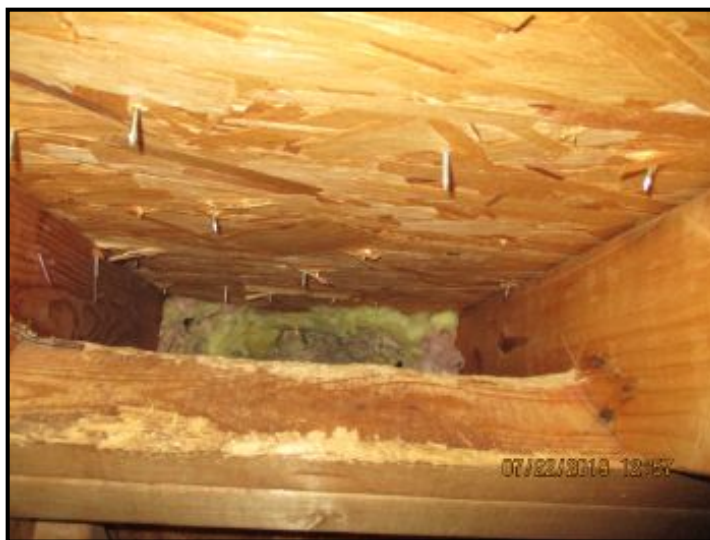
INVESTIGATE FURTHER: There is evidence of rodent activity in the side attic areas of the bonus room. Rodents typically inhabit the attic during cold months. I would consult a licensed exterminator for further evaluation.

Rodent damage in bonus attic area.

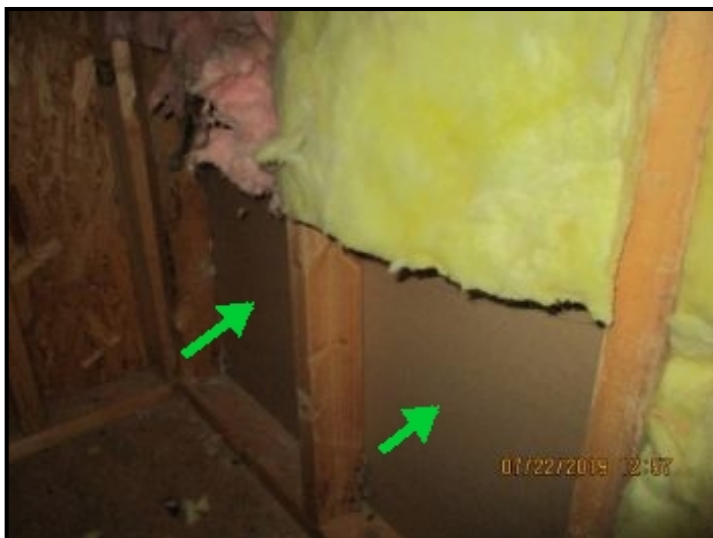
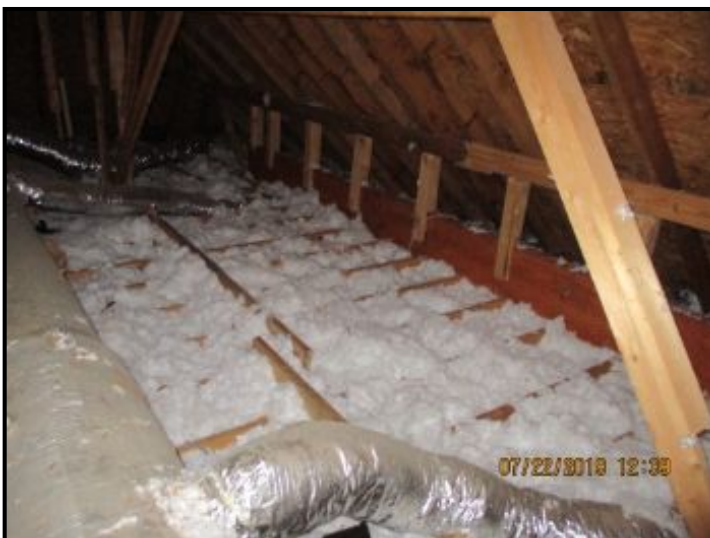
Some wall insulation is missing in the attic area over the garage. Have these walls insulated.

Wall insulation is missing.

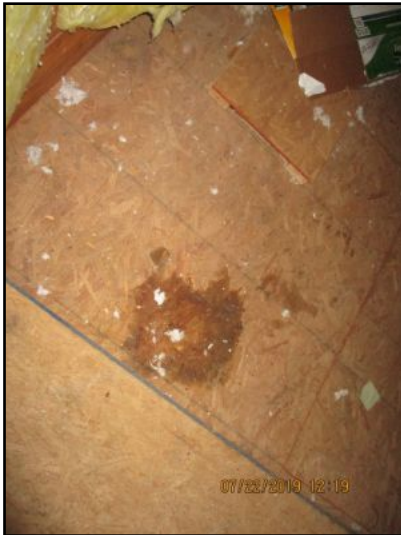
The refrigerant line in the attic is only partially insulated and dripping condensate on the structure. Have this repaired by a licensed HVAC contractor.

Condensate dripping on the structure.

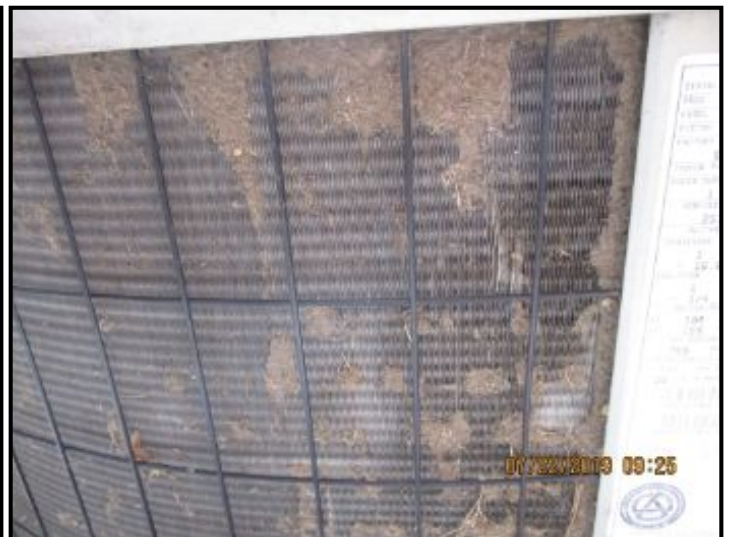
The coils in the condensing units are dirty. Have the coils cleaned by a licensed HVAC contractor.

Condensing coils are dirty.

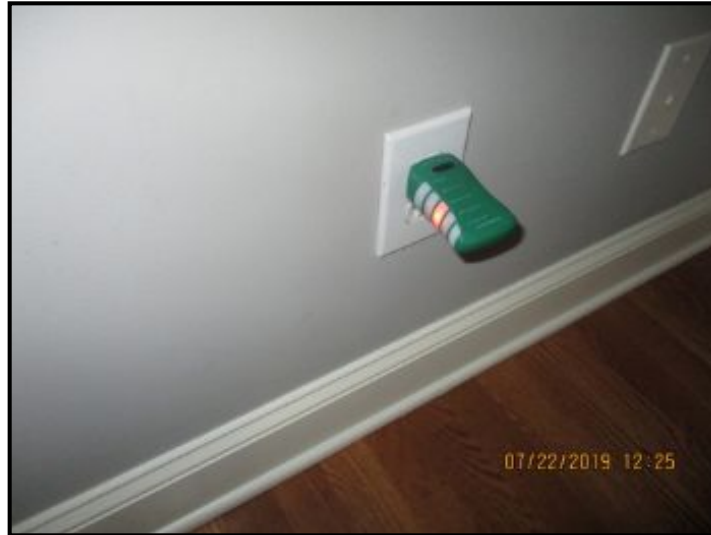
A receptacle in the bonus room(closet wall) and first bedroom(hall wall) upstairs tested as ungrounded. It is likely a loose ground connection. Have this repaired by a licensed electrician.

Ungrounded receptacle

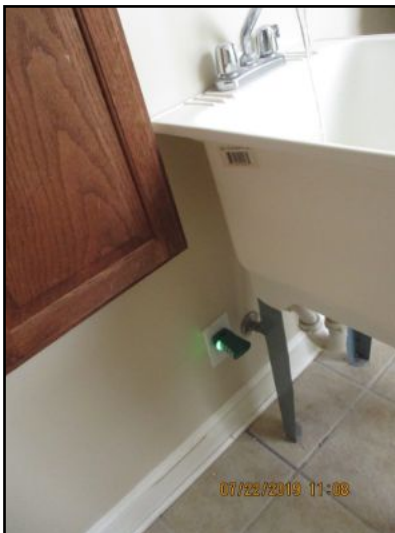
The receptacle under the laundry sink is not GFCI protected. This was required when the house was built. Have this repaired by a licensed electrician.

This receptacle need to be GFCI protected.

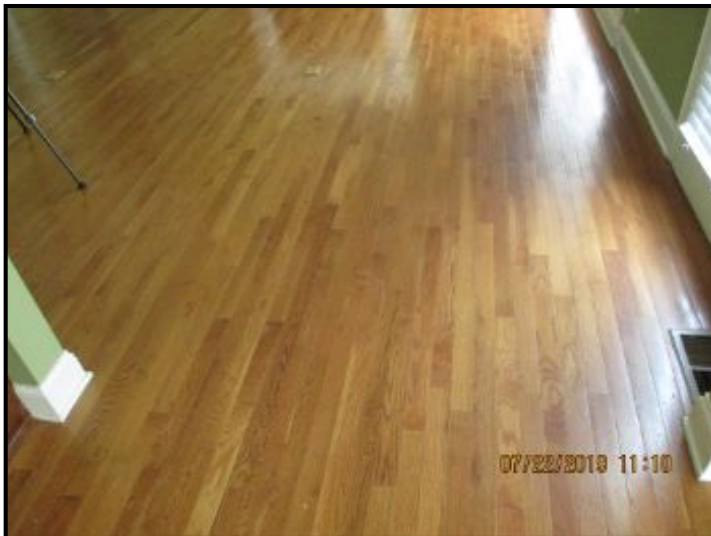
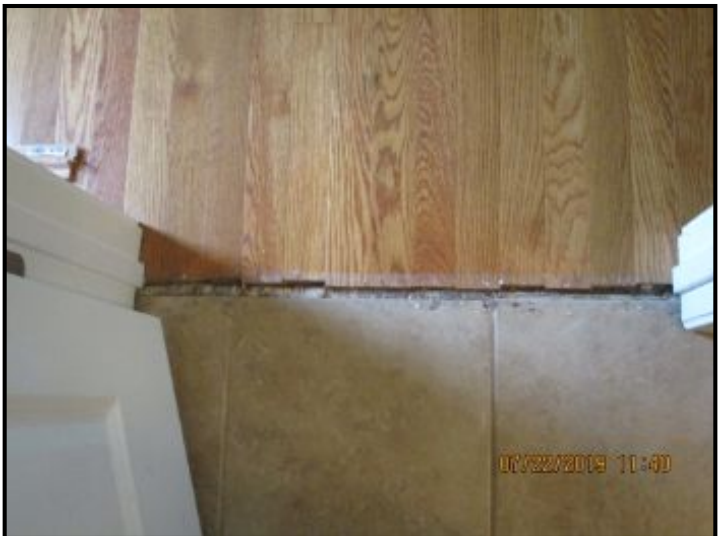
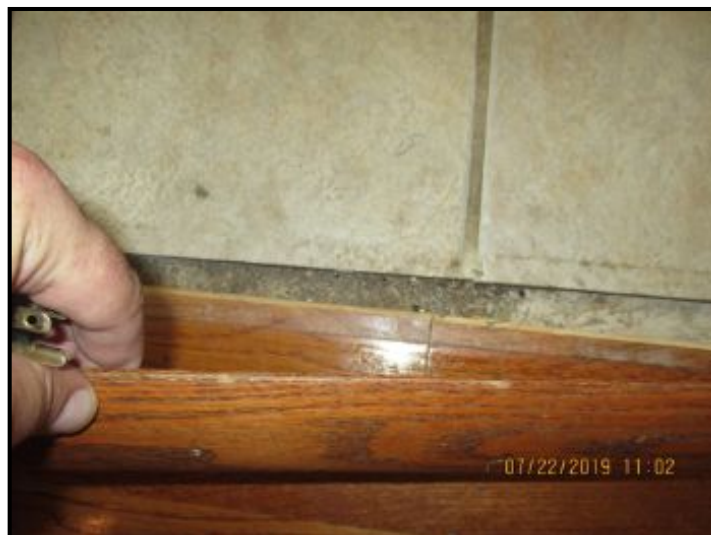
Transition strips at thresholds in the master bedroom/bathroom and laundry/kitchen are not installed properly. Have this repaired.

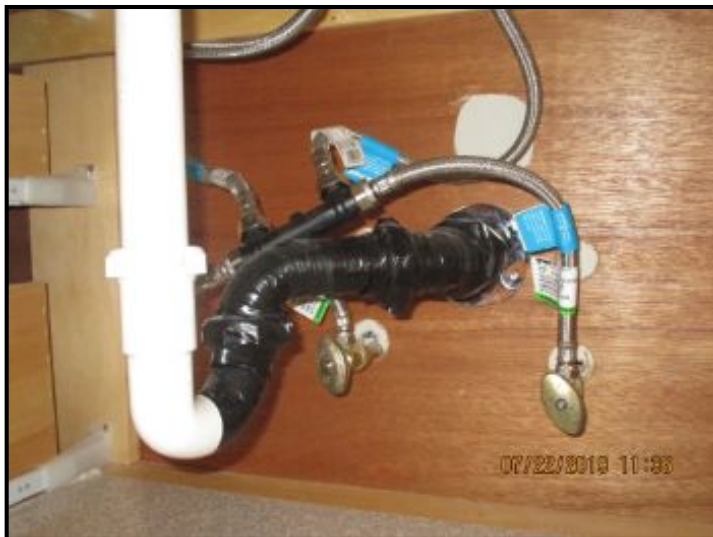
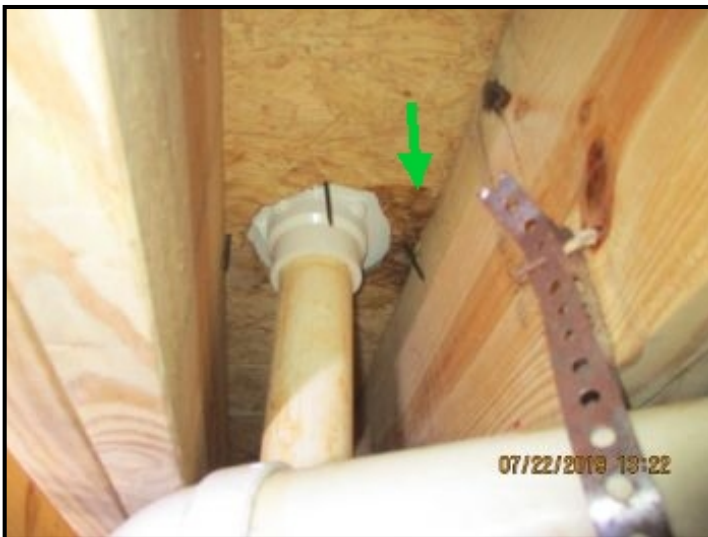
The master shower drain is leaking. (See notes in foundation section)

Master shower drain is leaking.

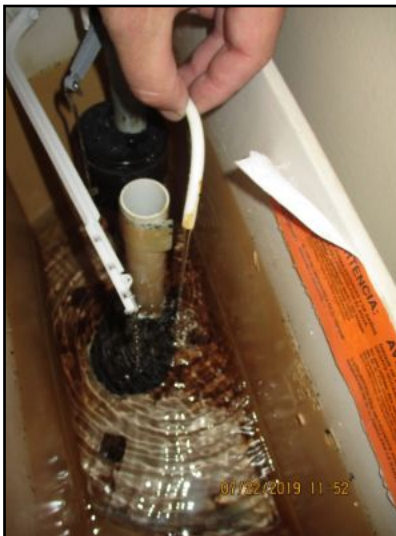
The toilet fill valve in the master bath is very slow. The valve may be clogged with sediment. Have this repaired.

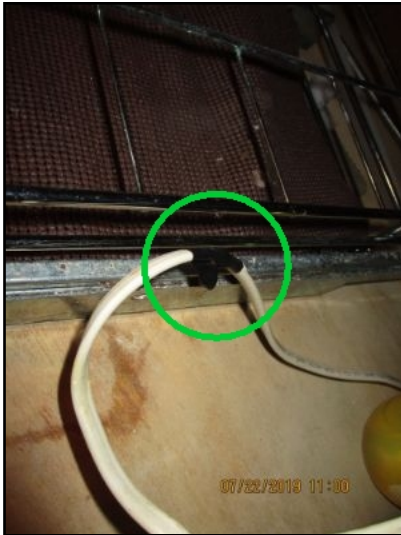
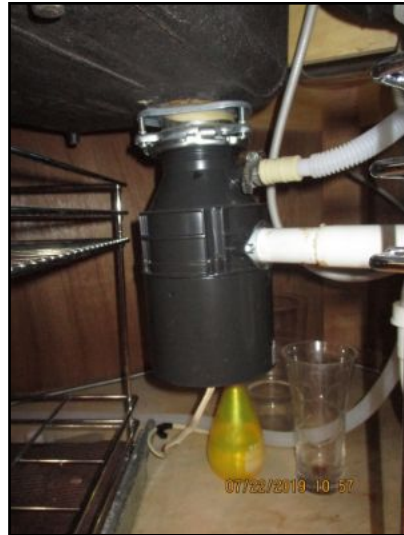
SAFETY: The disposal wire is spliced and wrapped with electrical tape. The wires need to be properly spliced with wire nuts inside of a junction box. Have this repaired by a licensed electrician.
