All Pro Home Inspection Services

Property Inspection Report

123 Fake Street, Somewhere, AL 35763
Inspection prepared for: SAMPLE REPORT
Real Estate Agent: -

Date of Inspection: 7/22/2019 Time: 9:00 AM
Age of Home: 2003 Size: 3776
Weather: Partly Cloudy Showers/86 F
Order ID: 210

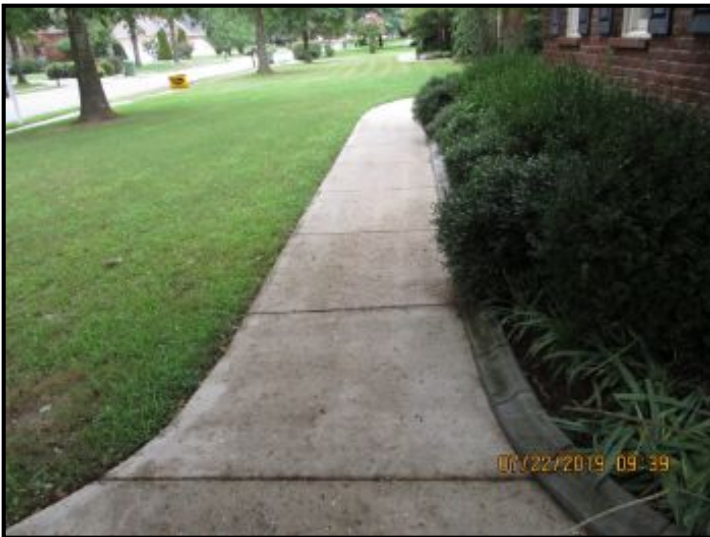
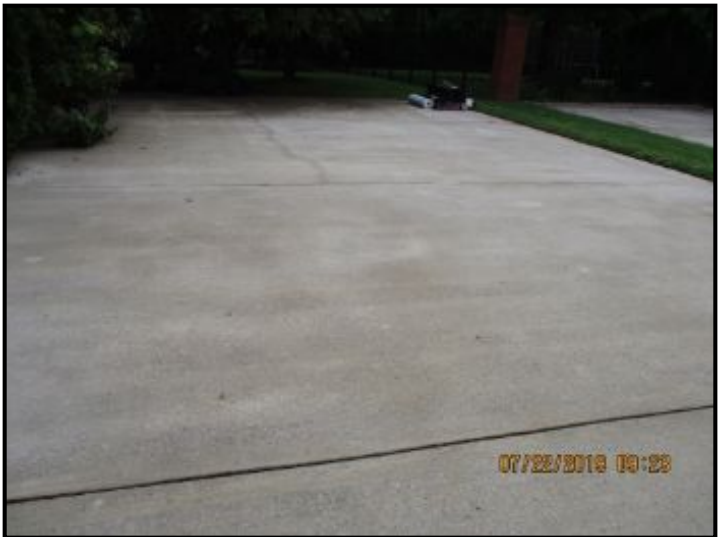
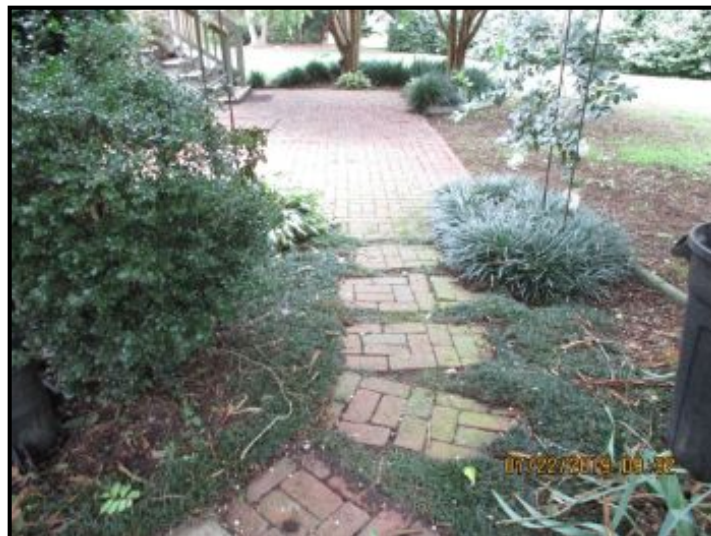
The driveway, sidewalk and patio are in adequate condition.

Typical cracks noted.

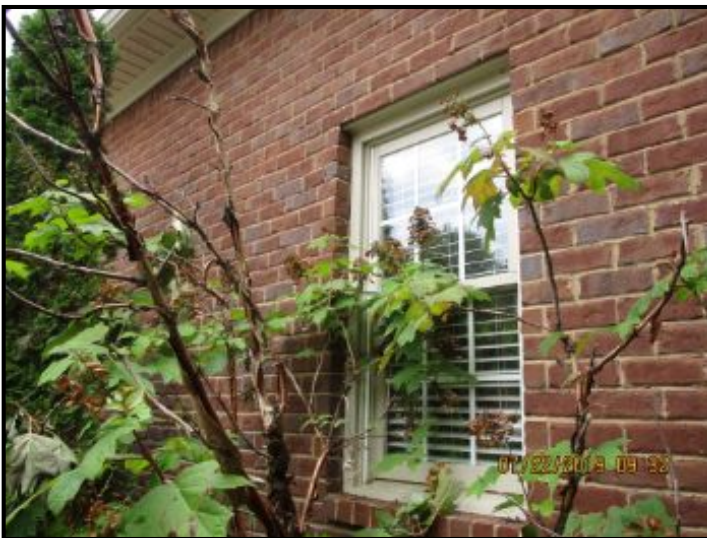
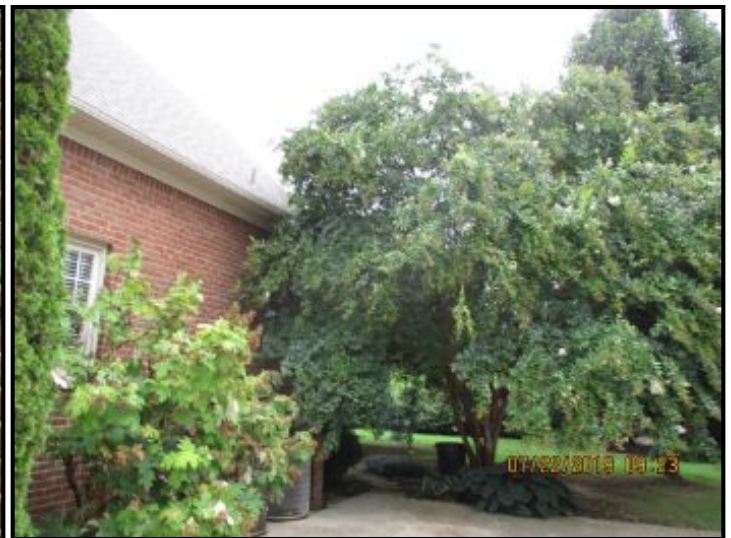
Vegetation growing on or too close to the house needs to be removed to allow sunlight in and prevent mold growth and eliminate paths for insects

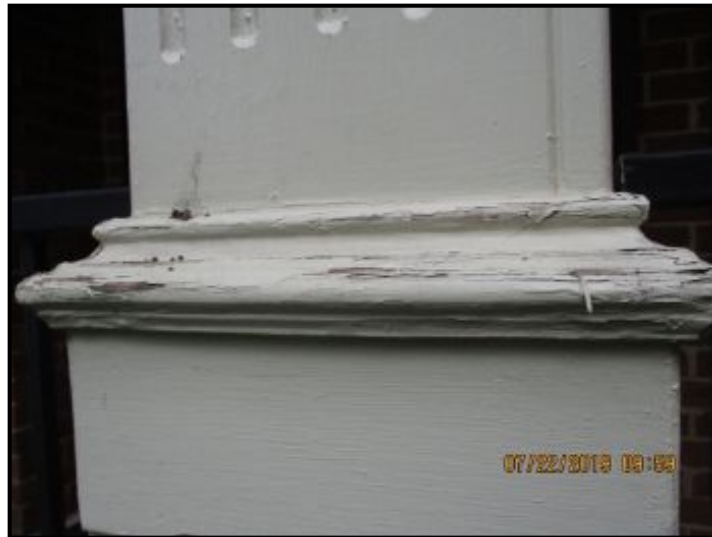
Missing trim on column.

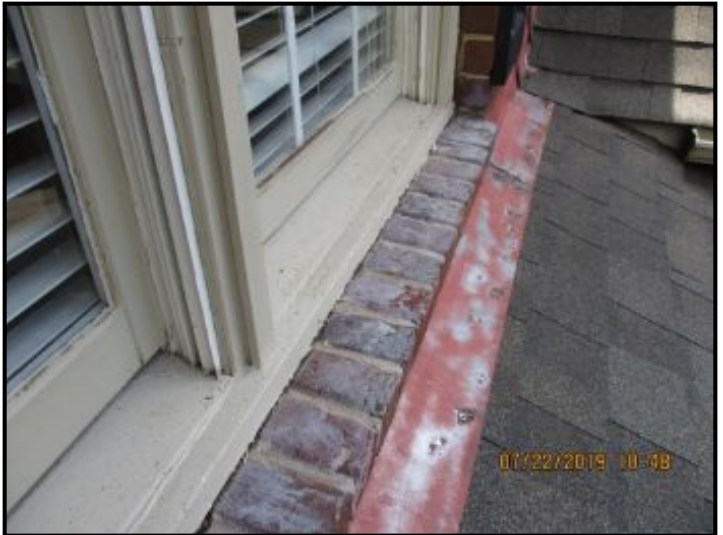
This flashing needs to be caulked.

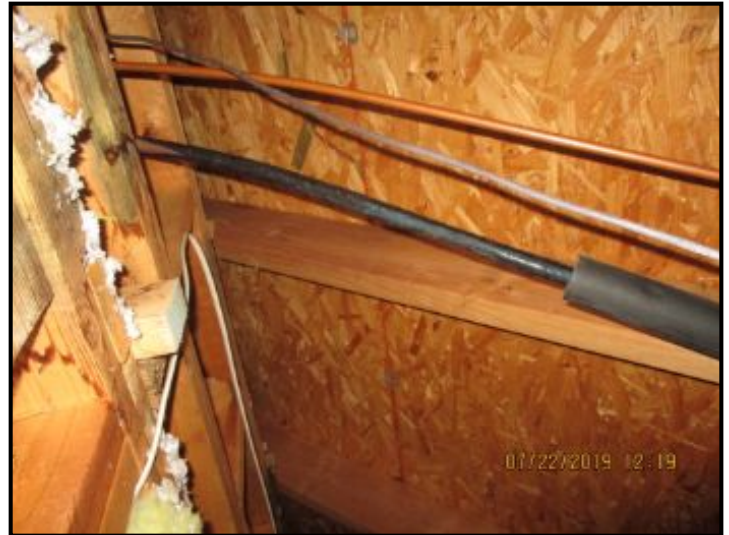
Condensate dripping on the structure.

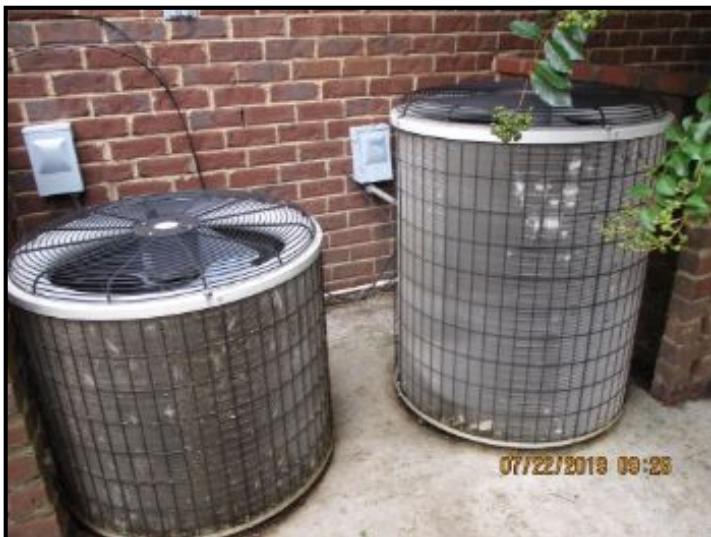
HVAC condensing units.

The heat pump for the second floor only achieved an 11 degree temperature differential indicating the system is in need of service. Have the system serviced by a licensed HVAC contractor.

The coils in the condensing units are dirty. Have the coils cleaned by a licensed HVAC contractor.

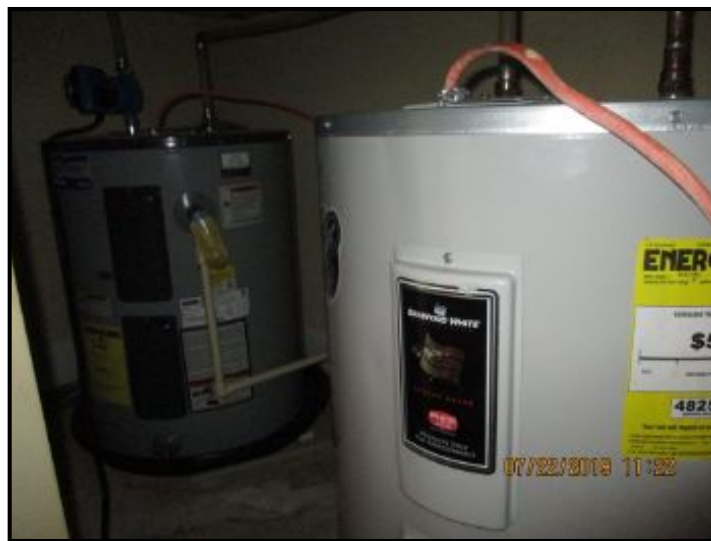
NOTE: A water heater or supply line may be leaking. Damage to the structure is visible from the crawl space.(See notes in the foundation section of this report)
